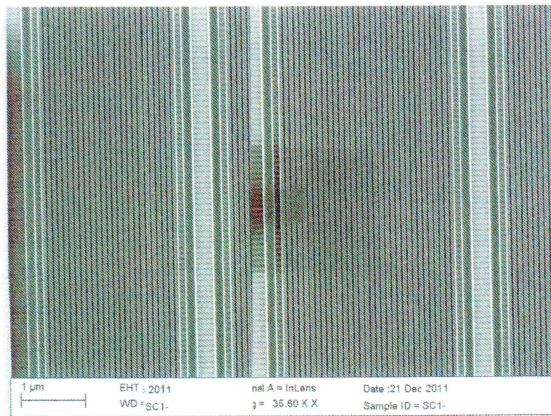
Before Cleaning

Imaging Conditions: 1.2kV Accelerating Voltage
144pA beam current 10 minutes scan time
6.08-10.6 Torr chamber pressure
